Risk Focus: Safe Carriage of Vehicle Cargoes

Car carriers, Ro-Ro and Ro-Pax ship safety
– A guide for shipowners, ship managers and crew

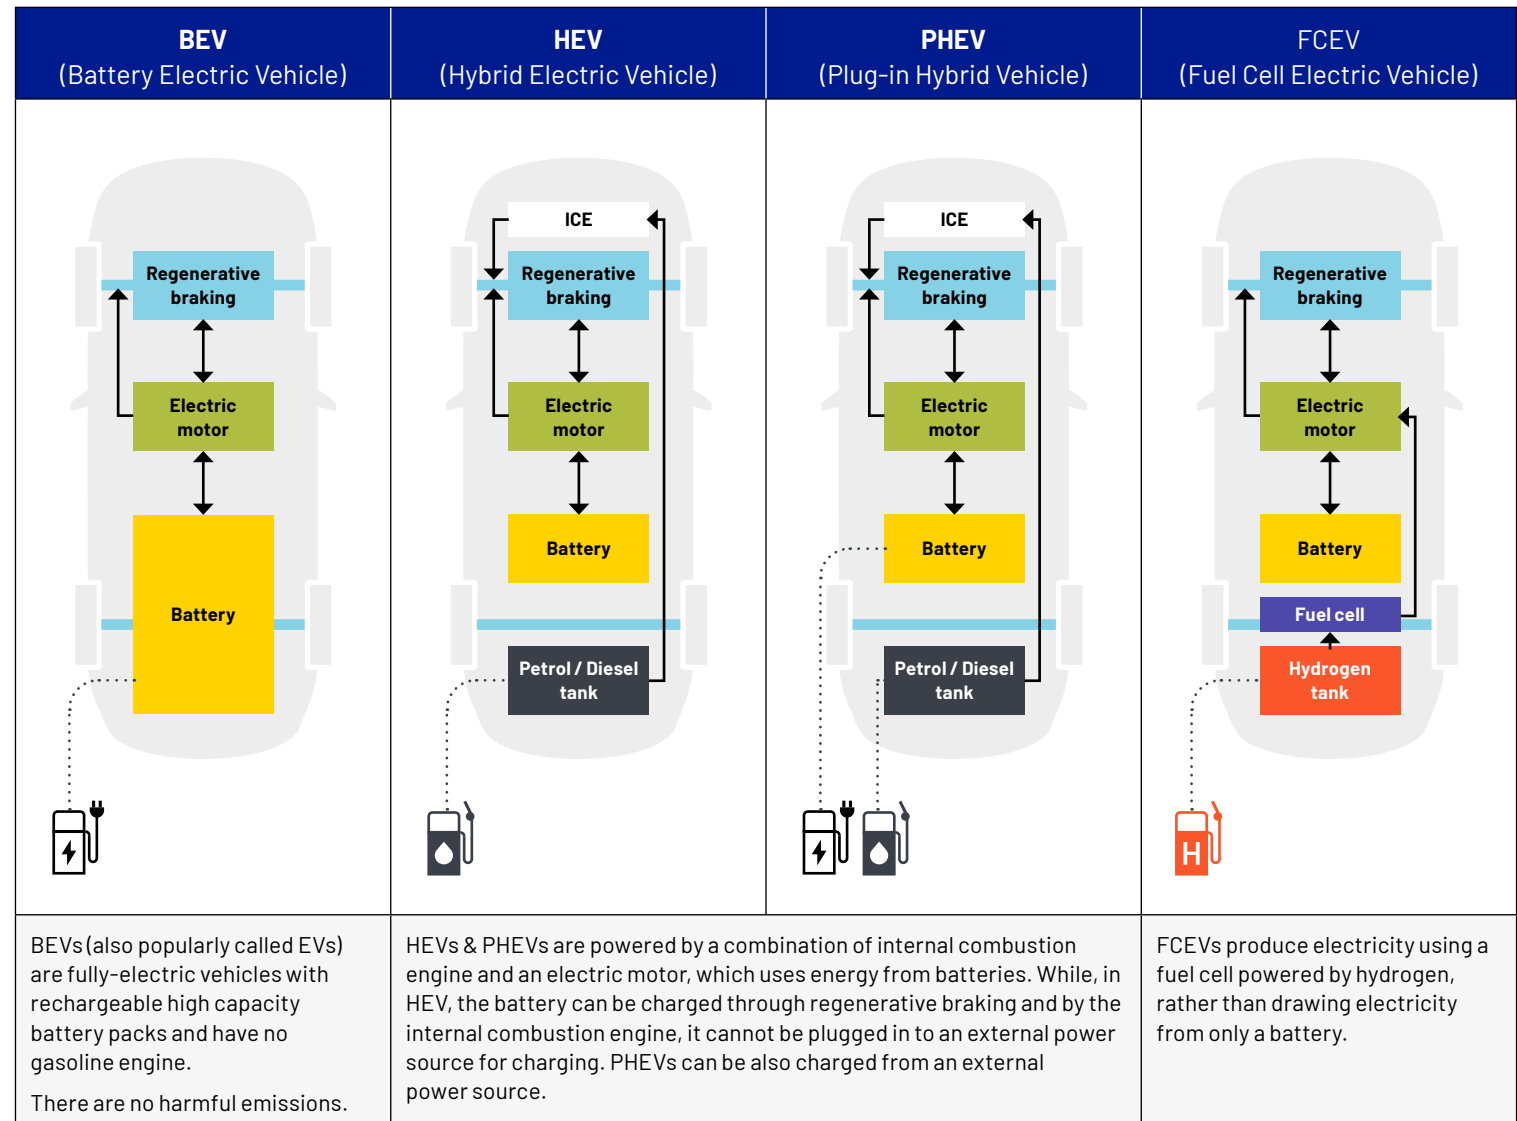
Figure 1: Diversified electrical vehicle technologies

To effectively assess the risks involved with carrying EVs, it is essential to understand the technical design of different types of EVs. Broadly speaking, there are currently three types of EVs:

- Fully electric Battery Electric Vehicles (BEVs), which have a battery pack that usually extends under the entire floor of the vehicle. At present, LiBs are the only technology capable of delivering the energy density necessary for practical vehicle operation, although research into other alternatives is ongoing;
- Hybrid Electric Vehicles (HEVs) and Plug-in Hybrid Electric Vehicles (PHEVs), which are powered by an electric motor as well as an internal combustion engine (ICE) that is powered either by gasoline or diesel; and
- Fuel Cell Electric Vehicles (FCEVs), which use compressed hydrogen gas as fuel to generate electricity which in turn drives an electric motor.
