SAFETY CAMPAIGN

2025

INTRODUCTION

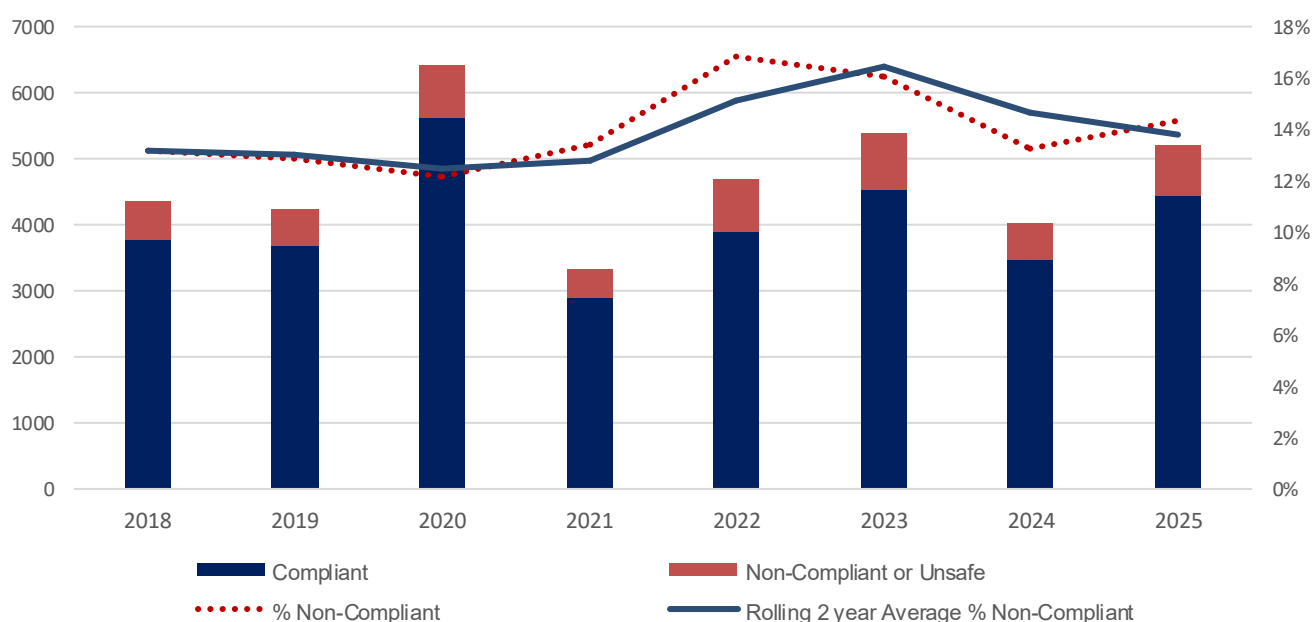
Compliance Trends, 2018 - 2025

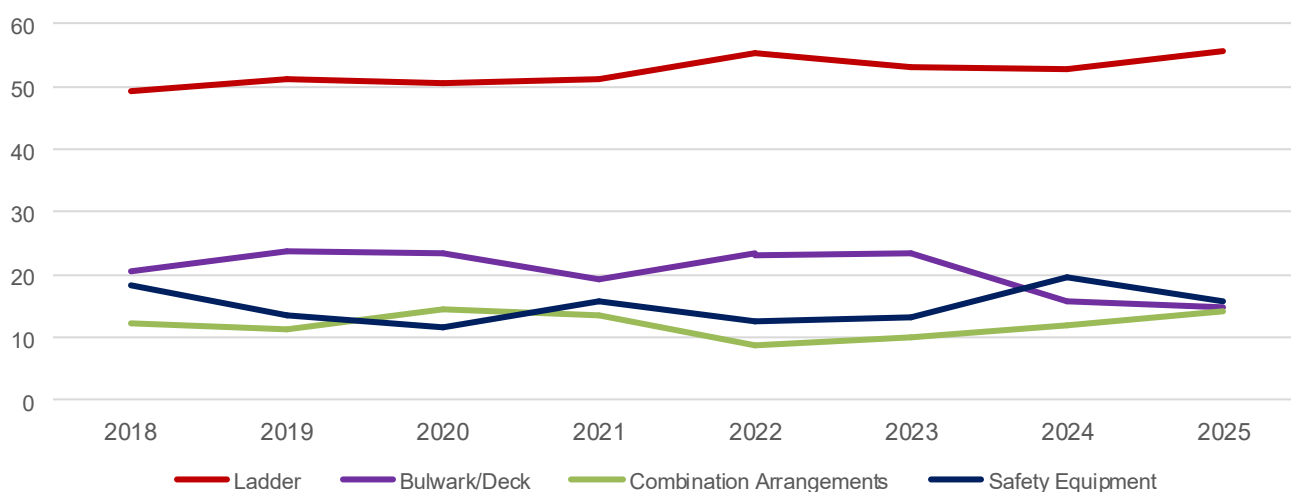
Drivers of Non-Compliance, 2018 - 2025

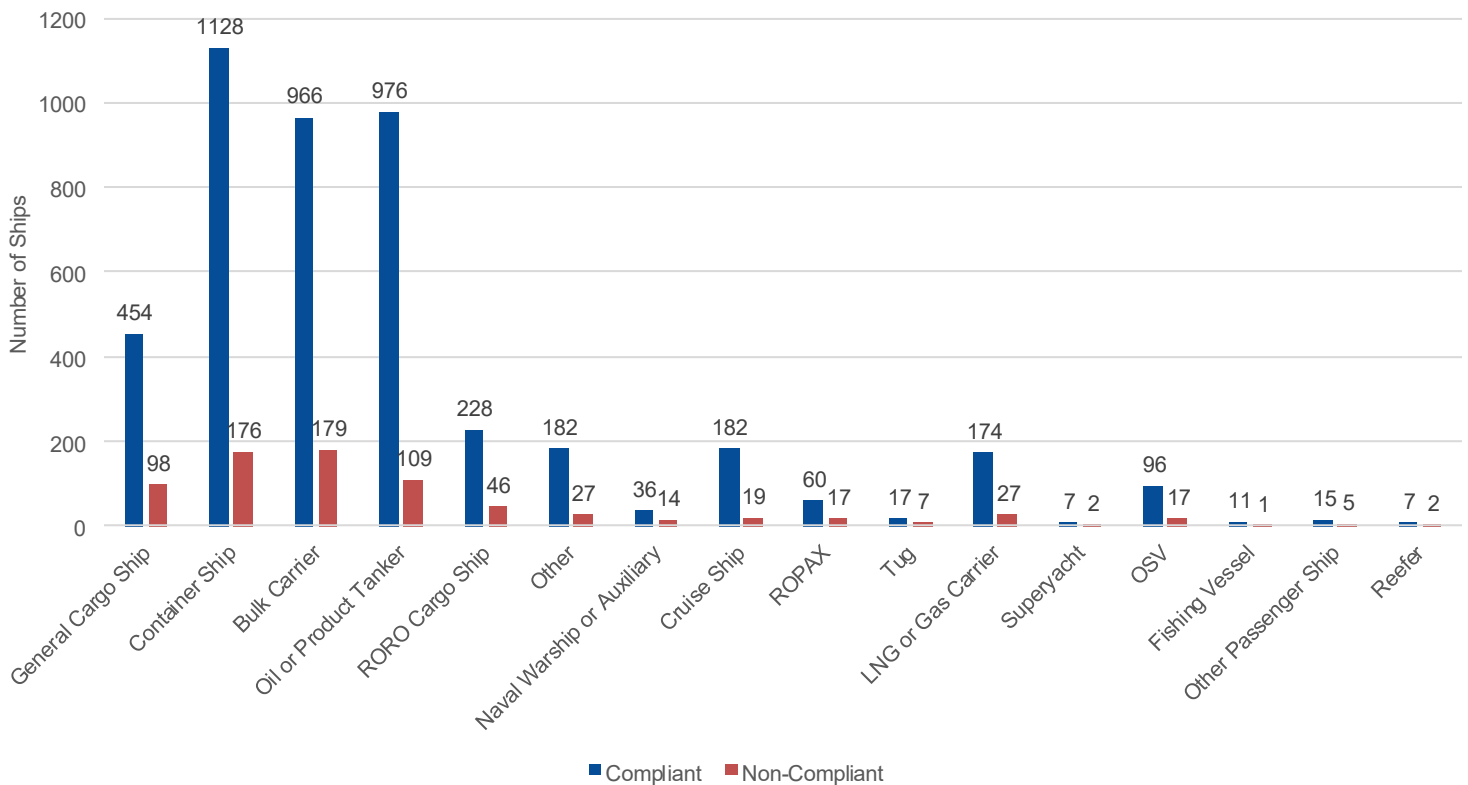
Ship Type	Total Ships	Compliant	Non-Compliant	Non-Compliance Rate (%)
Container Ship	1304	1128	176	14
Bulk Carrier	1145	966	179	16
Oil or product Tanker	1085	976	109	10
General Cargo Ship	552	454	98	18
Cruise Ship	201	182	19	10
RORO Cargo Ship	274	228	46	17
Other	209	182	27	13
LNG or Gas carrier	201	174	27	13
OSV	113	96	17	15
ROPAX	77	60	17	22
Naval	50	36	14	28
Tug	24	17	7	29
Reefer	9	7	2	22
Other passenger Ship	20	15	5	25
Superyacht	9	7	2	22
Fishing Vessel	12	11	1	8

Compliance by Ship Type

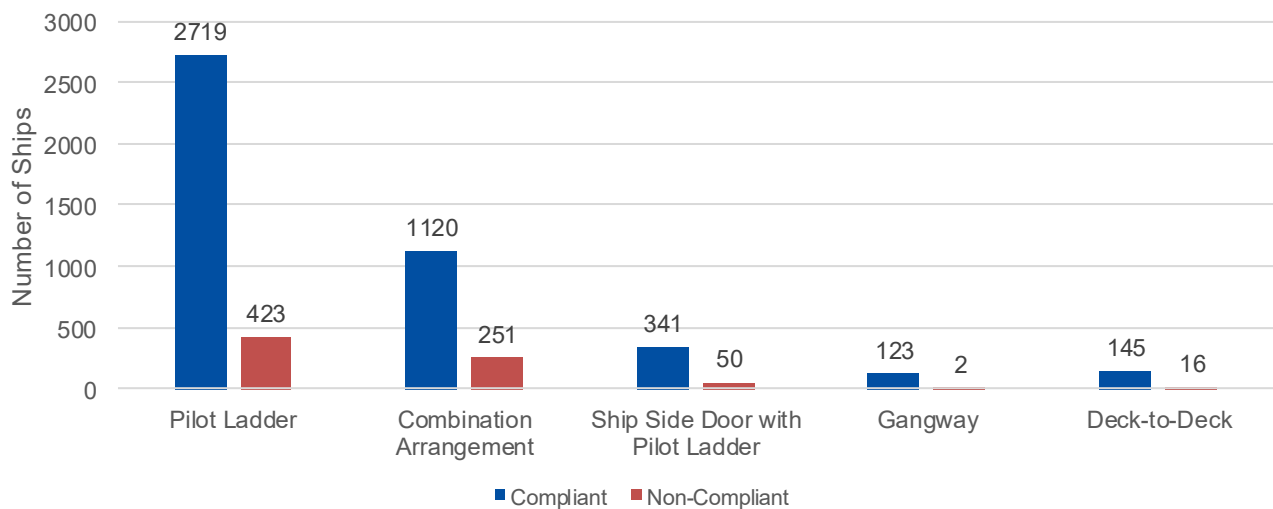
Compliance by Means of Transfer	Total	Compliant	Non-Compliant	Non-Compliance Rate (%)
Pilot Ladder	3142	2719	423	13
Combination Arrangement	1371	1120	251	18
Ship Side Door with Pilot Ladder	391	341	50	13
Gangway	125	123	2	2
Deck-to-Deck	161	145	16	10

Compliant and non-compliant by means of transfer
(Excluding Helicopter)

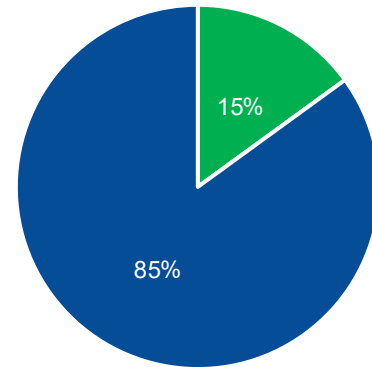
The first pie chart shows the percentage of the defects that were reported to the appropriate authorities, including but not limited to Port State Control. The second pie chart shows non-compliance by element of the pilot transfer arrangement. Both the number and percentage are shown.

% of non-compliant pilot transfer arrangements reported to authorities

Total number of non-compliant reports	723
Number of non-complaint pilot transfer arrangements reported to the appropriate authorities	108
Number of non-complaint pilot transfer arrangements not reported to the appropriate authorities	615

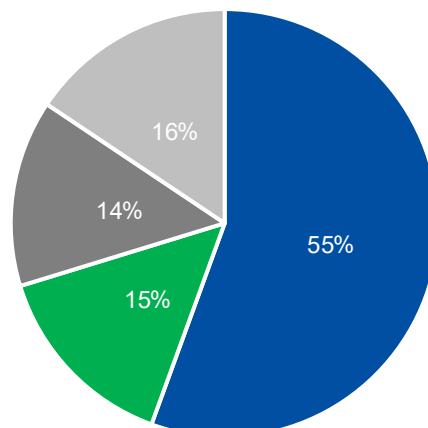
Non-Compliant by Element of the Pilot Transfer Arrangement	Total Number of Reports	% of Total Reports
Pilot Ladder	665	56
Access to the Deck	176	15
Combination Arrangement	169	14
Safety Equipment	187	16

% of non-compliance by element of the pilot transfer arrangement

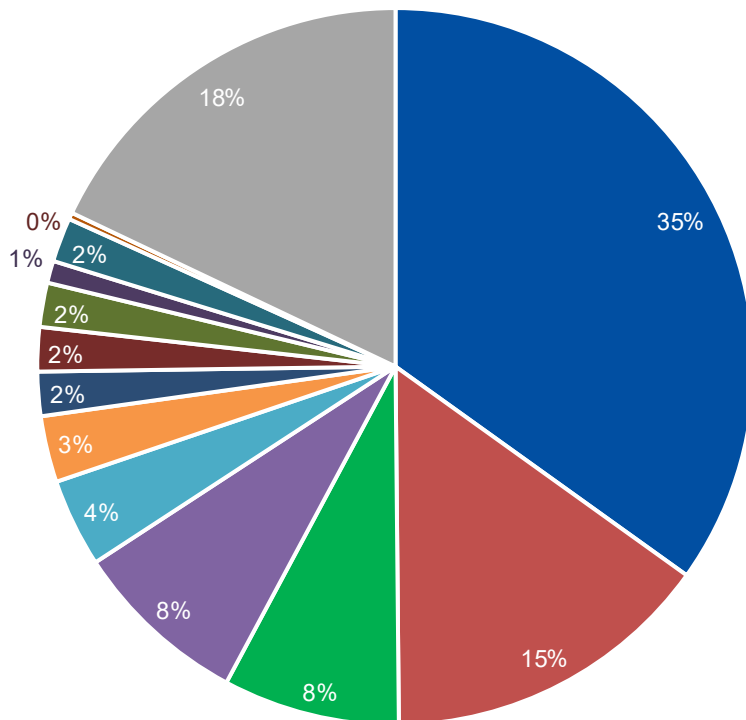
Defect	Total	% of all pilot ladder defects
Incorrectly rigged retrieval line	234	35
Steps not horizontal	100	15
Pilot ladder not against the hull throughout its entire vertical length	56	8
Pilot ladder not within the midships half length of the ship	50	8
Incorrect step fitting	28	4
Sideropes of unsuitable material	17	3
Steps slippery or contaminated	16	2
Steps not evenly spaced	13	2
Climb on pilot ladder greater than 9m	10	2
Steps painted or varnished	5	1
Steps broken	14	2
Steps made of a material other than hardwood, plastic or rubber	2	0.3
Other	120	18

Pilot ladder non-compliance by defect type

- Incorrectly rigged retrieval line
- Steps not horizontal
- Pilot ladder not against the hull throughout its entire vertical length
- Pilot ladder not within the midships half length of the ship
- Incorrect step fitting
- Sideropes of unsuitable material
- Steps slippery or contaminated
- Steps not evenly spaced
- Climb on pilot ladder greater than 9m
- Steps painted or varnished
- Steps broken
- Steps made of a material other than hardwood, plastic or rubber
- Other

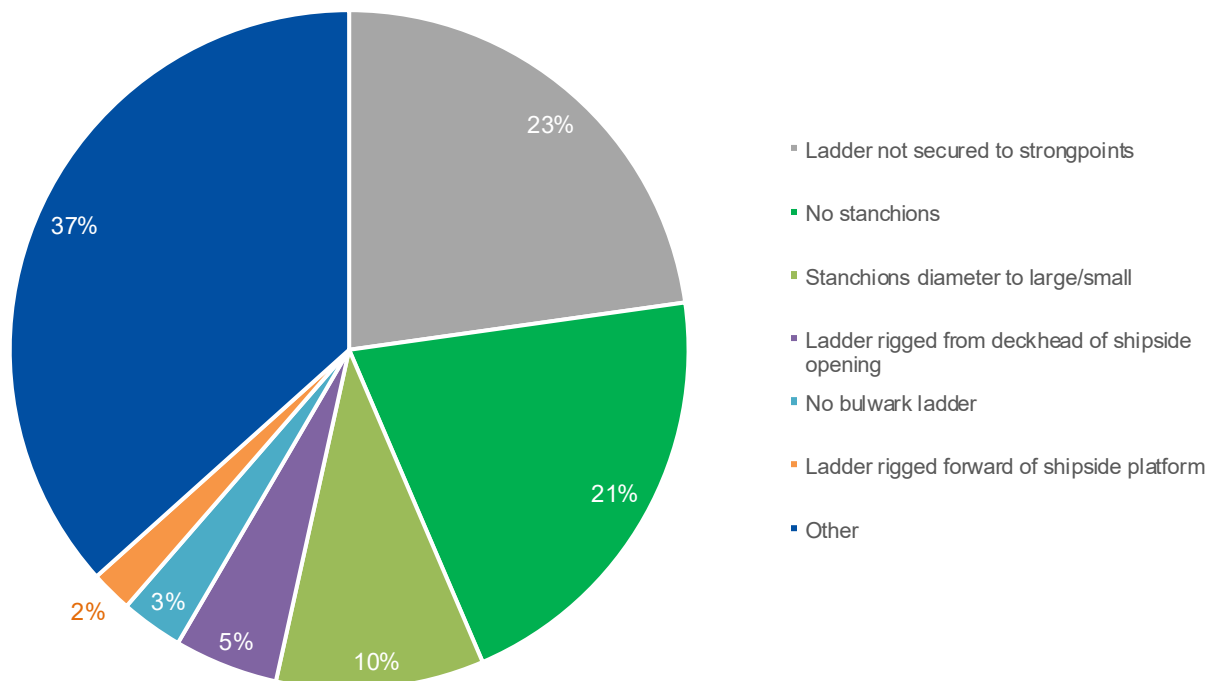
Defect	Total	% of all access to the deck defects
Ladder not secured to strongpoints	40	23
No stanchions	37	21
Stanchions diameter to large/small	18	10
Ladder rigged from deckhead of shipside opening	8	5
No bulwark ladder	5	3
Ladder rigged forward of shipside platform	3	2
Other	65	37

Access to the deck non-compliance by defect type

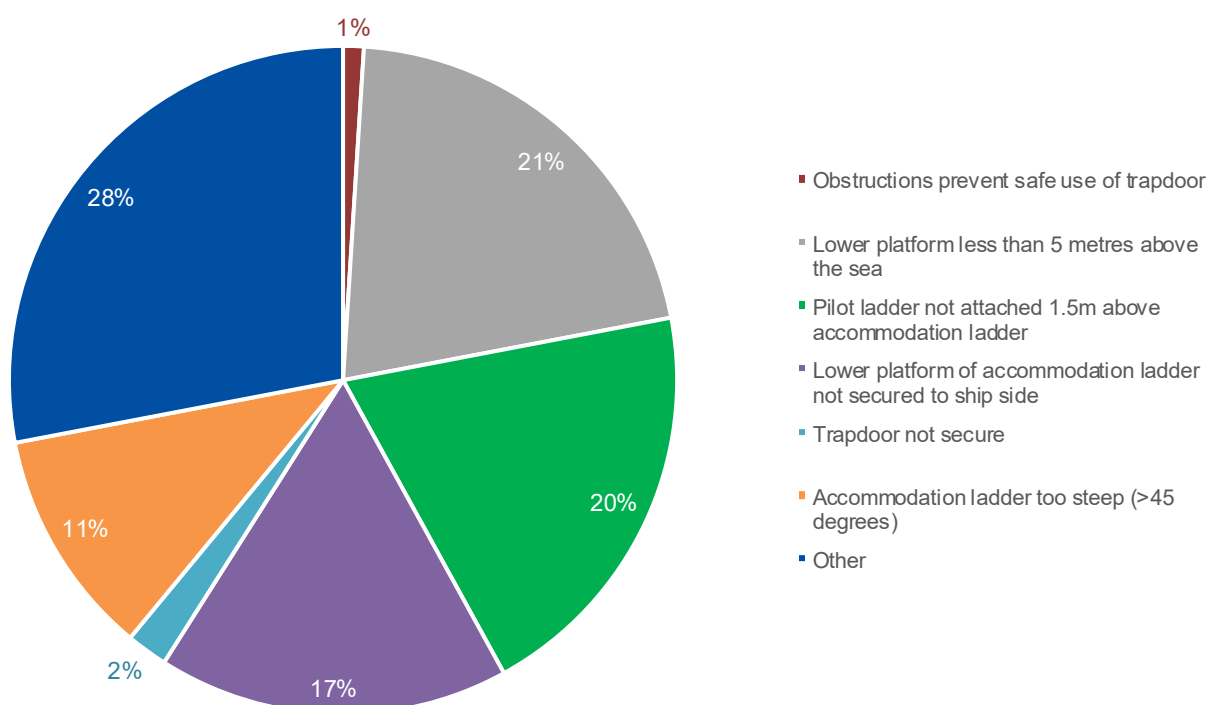
Defect	Total	% of all combination arrangement defects
Obstructions prevent safe use of trapdoor	2	1
Lower platform less than 5 metres above the sea	36	21
Pilot ladder not attached 1.5m above accommodation ladder	33	20
Lower platform of accommodation ladder not secured to ship side	28	17
Trapdoor not secure	4	2
Accommodation ladder too steep (>45 degrees)	19	11
Other	47	28

Combination arrangement non-compliance by defect type

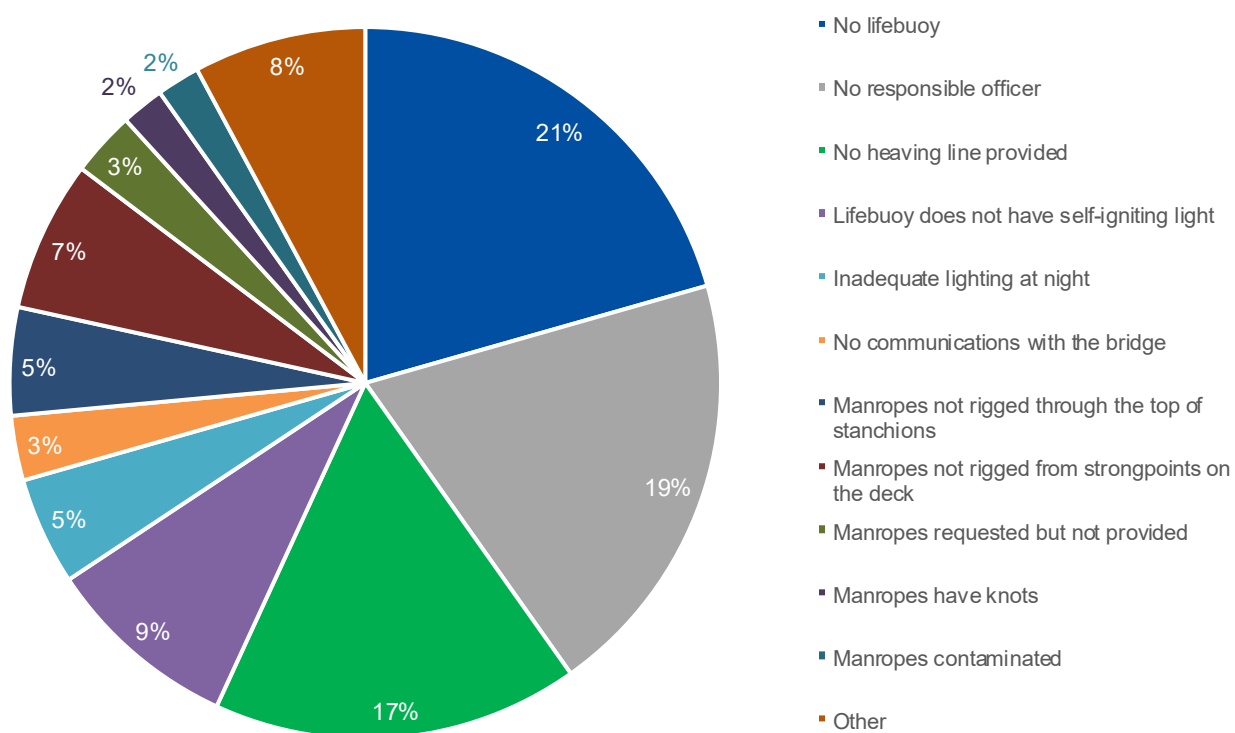
Defect	Total	% of all safety equipment defects
No lifebuoy	40	21
No responsible officer	37	20
No heaving line provided	31	17
Lifebuoy does not have self-igniting light	17	9
Inadequate lighting at night	9	5
No communications with the bridge	5	3
Manropes not rigged through the top of stanchions	9	5
Manropes not rigged from strongpoints on the deck	12	7
Manropes requested but not provided	6	3
Manropes have knots	3	2
Manropes contaminated	3	2
Other	15	8

Safety equipment non-compliance by defect type
