Seaways

The International Journal of The Nautical Institute

MARS Report No. 261 July 2014

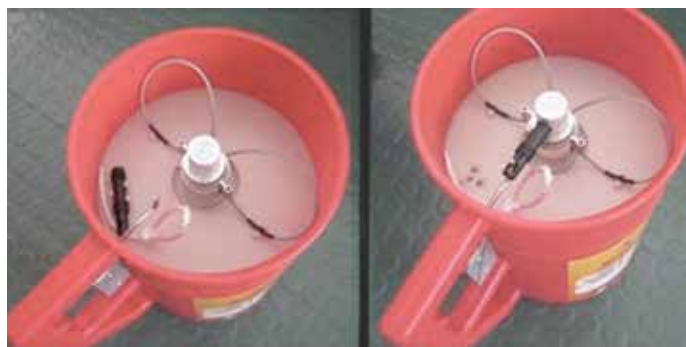
The vessel was provided with an IKAROS line throwing apparatus. The units were found in the un-armed condition; that is, the black plastic cylinder was not fitted between the rocket and the trigger. This means that the line throwing apparatus would not activate if the trigger was pulled. The plastic cover to the line throwing apparatus has a small label which states 'For safety during transit rocket is not armed. Rocket should be prepared for use once on board ship in accordance with enclosed instructions.'

Unarmed

Armed

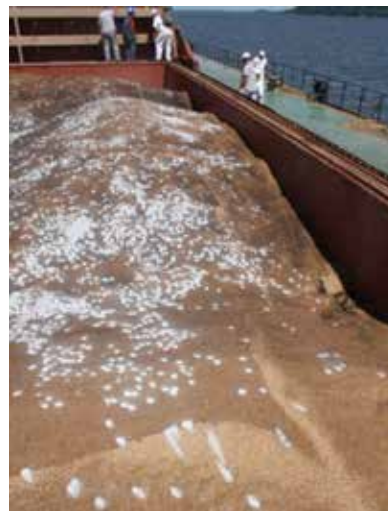
- Failure to unfold or uncoil belts, blankets, blister packs and ropes. This presents a fire hazard, and possibly an explosion hazard which worsens if moisture that condenses on the upper parts of the cargo space (sweating) drips onto the fumigant product. Under these circumstances a flammable phosphine:air mixture is more likely to form. If this mixture accumulates within an enclosed space such as a cargo hold or a drum fitted with a lid, it may ignite spontaneously and cause a fire.
- Too many pellets or sachets clustered together (see picture).
