UK P&I CLUB

# CAR MATTERS

*Car Carriers, Ro-Ro and Ro-Pax Ship Safety  
— A Guide for Crew*

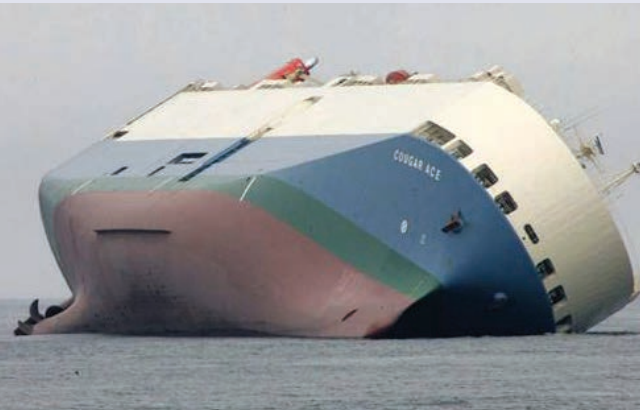
**‘COUGAR ACE’**  
Date: 23 July 2006  
Location: 230 miles south of Aleutian Islands, North Pacific  
Ship Type: Car carrier  
Fatalities: 1 member of salvage team

‘COUGAR ACE’  
(image – U.S. Fish and Wildlife Service)

‘COUGAR ACE’ was en route from Japan to the USA with a cargo of 4,812 vehicles. During the voyage the crew were carrying out ballast water exchange operations (BWE) in preparation for entering US waters. During that process, the ship’s starboard ballast tanks failed to refill, which reduced the GM to zero. Loss of stability and wave action caused the ship to assume an angle of loll of 60 degrees to port, which meant that the propeller and rudder were no longer submerged. Sufficient righting moment remained at that angle of heel, due to the ship’s large freeboard, and further listing to port and possible capsize was prevented.

The ship was salvaged and towed to the Aleutian Islands where portable pumping equipment was used to first increase the bottom weight within the ship. Once sufficient stability had been regained, it was brought upright again.

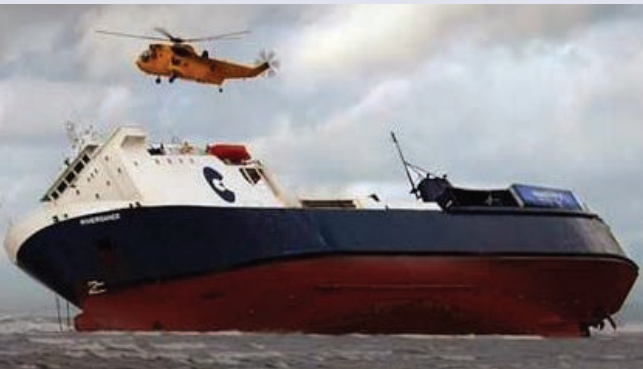
**‘RIVER DANCE’**  
Date: 31 January 2008  
Location: Irish Sea  
Ship Type: Ro-Ro passenger ferry  
Fatalities: 0

‘RIVERDANCE’  
(image – www.fortunes-de-mer.com)

The ship departed Warrenpoint when weather forecasts predicted gales of force 8 to storm force 10 conditions in the Irish Sea. Departure draughts were read but no stability calculation was made prior to departure. Despite the prevailing weather conditions, the ship was noted to be only rolling gently due to her good seakeeping characteristics. However, as the ship approached shallower water of Heysham, the sea state worsened and the roll motion increased, resulting in some of the cargo shifting and causing an eventual list to port of around 35 degrees. The ship drifted towards the shore and eventually grounded with a list of about 5 degrees.

Various ballasting operations were carried out to prepare for a refloat attempt which failed and resulted in the ship grounding again with a 30 degree list to starboard. The ship was finally declared a constructive total loss and scrapped in situ.
