The Nautical Institute Marine Accident Reporting Scheme

MARS Report No 187 May 2008

MARS 200833 Major gas leak

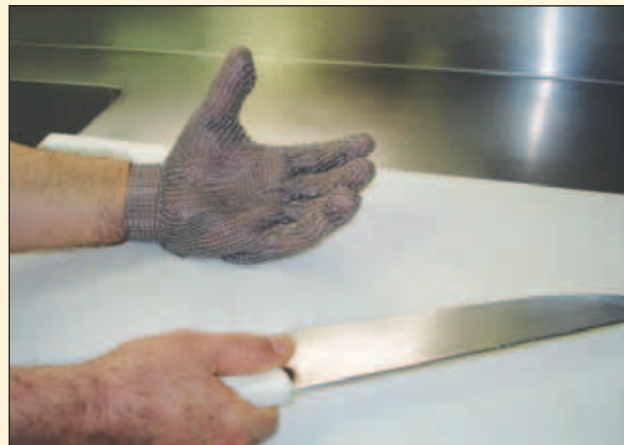
Chain-mail gloves, which are easy to clean in hot soapy water, are a good idea particularly when cutting meat. Ships' officers are advised to procure these in consultation with their management offices. These gloves are regularly used ashore by butchers, and in the meat-packing industry, by scuba divers and by animal control officers (against animal bites).

▲ Chain-mail gloves
