# Carefully to Carry

SEPTEMBER 2006

## Stuffing and stacking containers

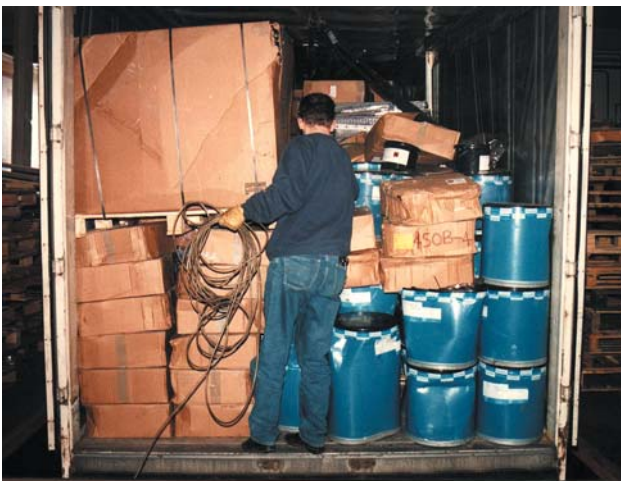
*Photo 1: Poorly stuffed container – note the damaged packages, the pallet on top of cartons and the apparent lack of securing arrangements*

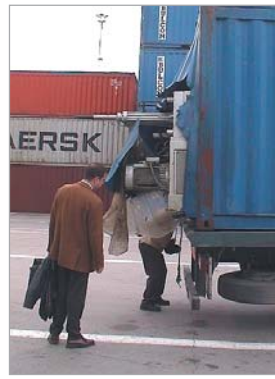
*Photo 2: Inspection of goods in container terminal*

*It should always be borne in mind that the side panels, the end panels, and the roof panels of an ISO container are not normally strength members.* Beneath the floor timbers there are metal cross-bearers and it is generally those bearers which provide the floor's strength. Additionally, the corner posts, front and rear headers and front and rear sills provide the internal strength members. (See Fig. A). Whenever bracing is to be used in vertical, horizontal or diagonal form, it must act against those members and the floor bearers, and no others. Bracing and/or end chocking against side, end, and roof panels will surely result in disaster (photos 2 and 3).

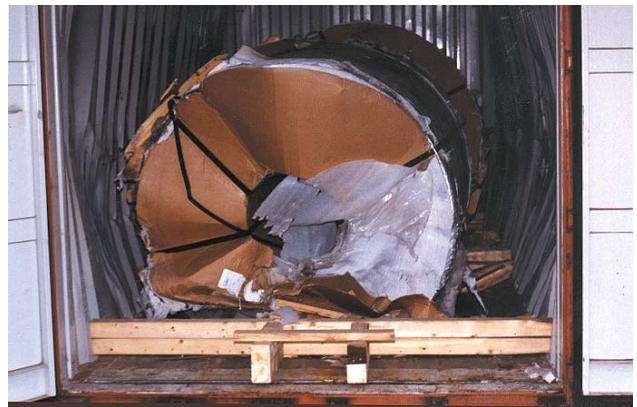
*Photo 3. Note the damage caused to the container by the poorly secured coils*

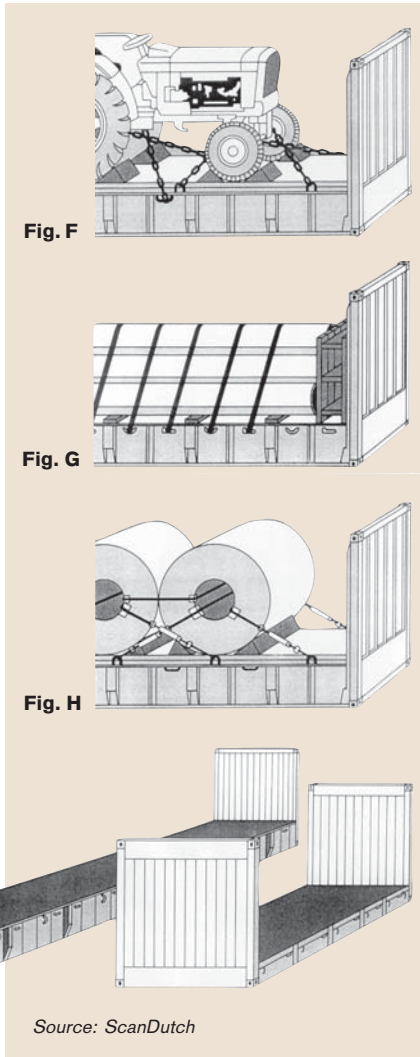
Fig. E

items should be shipped on specially designed 'flat racks', 'flats' or 'sledges'. (Fig. E).

These units are strengthened for such loads, and adequate securing terminal points are provided. (Figs. F, G & H, for instance.)

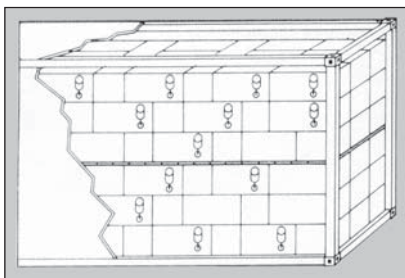
Fig. B

Where relatively lightweight cartons or good timber cases can be afforded tight block stowage, there will be little need for additional securing arrangements. However, where lightweight cartons with frail contents, or plastic jars, bottles and barrels, are to be stowed to the full internal height it may be necessary to provide a mid-height flooring so that the lowermost items do not suffer damaging compression and collapse. (Figs. B & C).

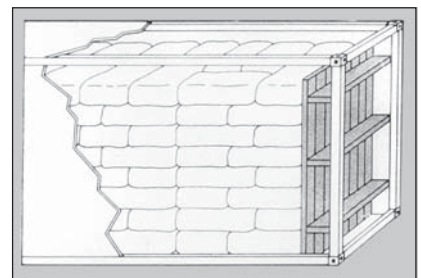
Fig. D

Where bags, cartons or cases do not occupy the full internal space, then chocking and bracing with timbers and/or air bags is necessary. (Fig. D).

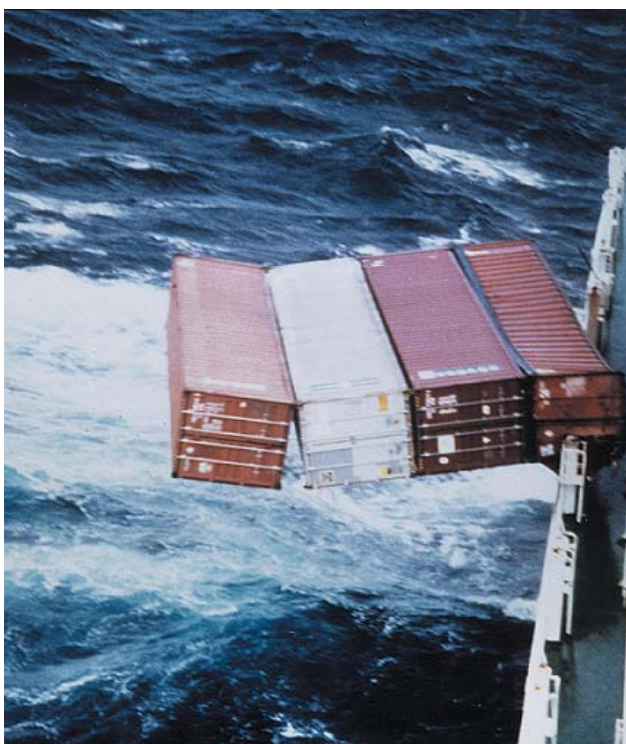
Photo 5: The ultimate lashing failure

Firstly, it is found that container stacks have failed because a fully-approved and fully adequate securing system has become downgraded with time. That is to say, after the casualty all concerned aboard the vessel insist that “we always secure them that way” when what proves to be the case is that, over time, one small recommended aspect after another has been omitted incrementally and successively without casualty until the day that circumstances conspire to subject the stacks to the maximum stress which the system was designed to withstand. Damage and loss result. A chain is only as strong as its weakest link, and a container stack securing system is only as effective as its least efficient component. *Do not omit from a container stack securing system any single component which comprises the full and approved arrangement.*

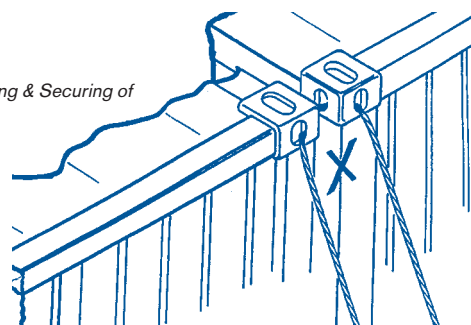
Fig I. A recipe for disaster. Adjacent corner castings should never be loop-lashed like this, or similar.

Thirdly, where two 20ft units are stowed on the weather deck in what would otherwise be a 40ft unit position, it is very difficult – in many instances, impossible – to apply wires, chains or bar-lashings to the adjacent end-butting corners. Their absence is not compensated for by using double or four-way inter-layer stackers (spades) or longitudinally positioned screw-bridge fittings, tie-wire, or the like. (Fig. I).

The problem is that the container stack as a whole, and particularly those units in the base tier, will be subject to excessive wracking stresses should the ship start rolling in heavy seas or pronounced swell conditions. Some compensation can be applied by the use of anti-rac bands (two tensioned metal straps fitted diagonally across the corners of the 'free' ends of the base tier containers) but they suffer from the same inability to secure the 'butting' ends. A full lashing system, properly planned for the dual carriage of 20ft and 40ft units is to be preferred if container losses from this cause are to be prevented
