Technical Bulletin

NUMBER 3 2002

Plastic piping

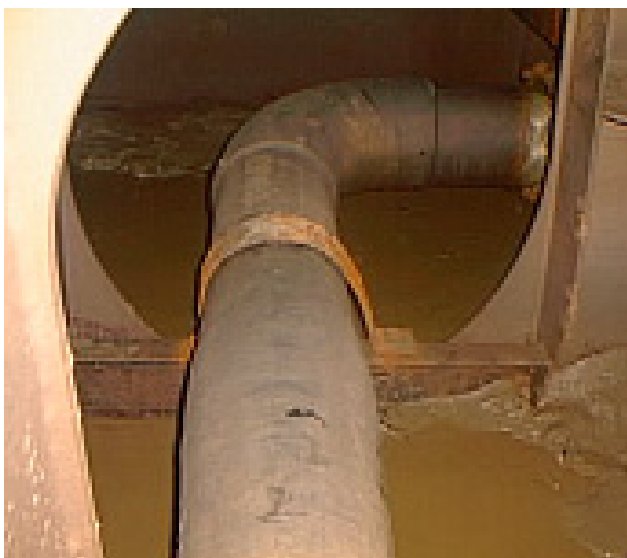
1. Pipes in double bottom and side tanks are normally continuous lengths secured by metal hoops to the frames of the tank. Over time, the strength of these hoops is degraded by corrosion which can allow the pipe to shift under the pressure of the water passing through it, or from a *hydraulic shock* caused when a valve is opened and water rushes in to fill the void in the pipe. This can cause cracking of the pipes and problems at flanges that are required to pass through tank bulkheads.

Weakness in the hoop (photo, below left) has allowed the pipe to shift under pressure and caused it to pull out of the flange at the tank bulkhead (photo below).

It is recommended therefore, that ship's personnel should pay particular attention to these pipes when inspecting ballast spaces in the normal course of planned maintenance and cleaning, and that any damaged securing hoops should be replaced as soon as possible.

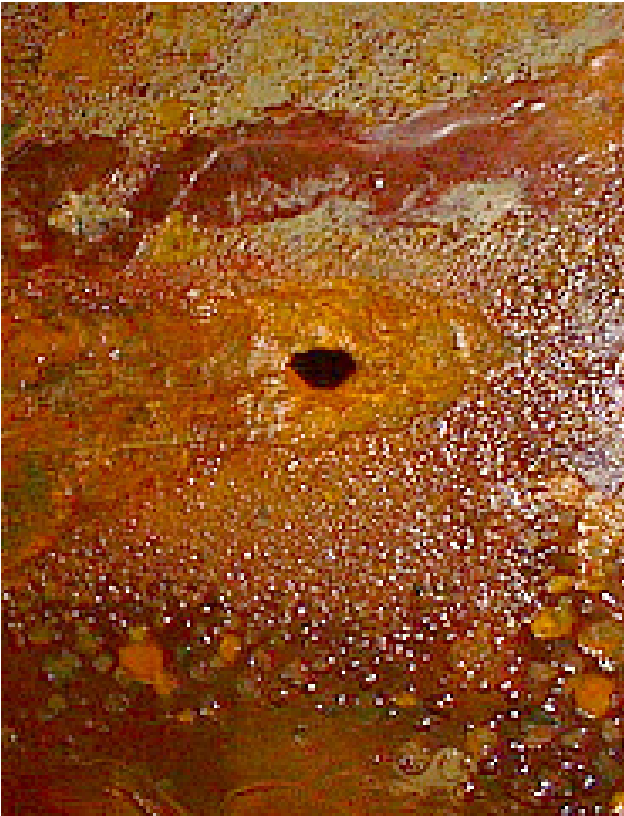
2. Where plastic pipes are used at tank suction bells or in wells of tanks for suction, such pipes are very much less prone to erosion caused by the suction turbulence and, in fact, the steel of the tank is more liable to be eroded heavily under these suction bells, which can lead to serious holes forming in shell plating.

An erosion hole is shown below, found in a coated ballast tank when the suction bell was removed.

In these areas it is recommended to check the plate thickness on a regular basis to avoid such problems and to renew the plate in good time to prevent holes occurring.
