# LP Bulletin

## Bulletin 694 - 05/10 - Loading Stores - Worldwide

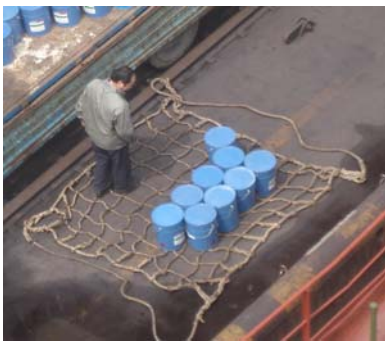
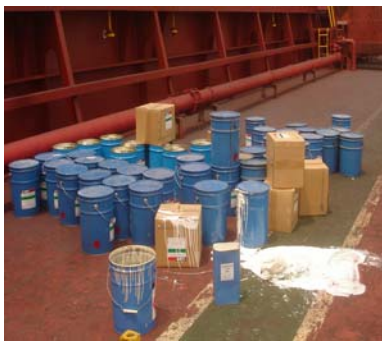
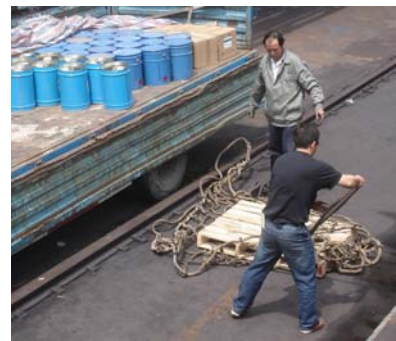
The incident in question occurred whilst a vessel was loading paint from the quayside. During the operation it was noticed that a pallet should have been used instead of loading drums directly into a cargo net.

During loading the drums came open and were damaged and as a result paint spilled out but fortunately there was no one underneath the load. If the paint or one of the drums had fallen, one of the crew could have been seriously injured or killed. It is vitally important that, when loading stores an officer or experienced member of the crew supervises the operation so that bad practice and potentially dangerous situations can be avoided. Following the incident, a pallet was used.
