Ship Type: Bulkcarrier

Trade Area: Tanzania

Bulletin 258 - 08/02 - Weighbridge Accuracy - Dar Es Salaam - Tanzania

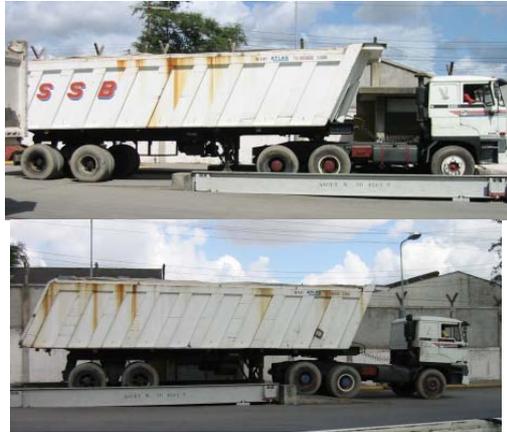
The following photographs highlight a novel way of saving time on a weighbridge not long enough to take a complete articulated unit.

We are advised that instead of uncoupling the trailer the front end of the unit is weighed, the unit then drives through leaving the rear axle on and another reading taken. The readings are then added together. This is done both empty and full the difference being the weight of the commodity.

- 1) That Members be aware that port weighbridge figures in Dar Es Salaam could be suspect
- 2) Members should contact the Club's correspondent if out turn figures are to be based on weigh bridge calculations alone.
- 3) Members should make charterers aware that there could be a problem with out turn figures in this port
- 4) As a general rule
 - a. Members should always make sure, if possible, hatches are sealed prior to leaving the load port in the presence of a third party surveyor
 - b. Invite Charterers/Receivers to attend at the discharge port to witness the seal breaking.

- c. Always conduct an independent draft survey, inviting Charterers/Receivers to attend.
- d. Closely monitor any spillage at time of discharge, keeping photographic and written evidence. If spillage is excessive contact the Club's correspondent
- e. If Members are faced with shortage claims based on weighbridge figures it is essential for weighbridge calibration records to be checked. The actual method of use of the weighbridge itself should also be checked for irregular practices as above.
