Ship Type Bulk Carrier/ Dry Cargo Trade Area Worldwide

Bulletin 261 - 09/02 - Hatch Coaming Drains

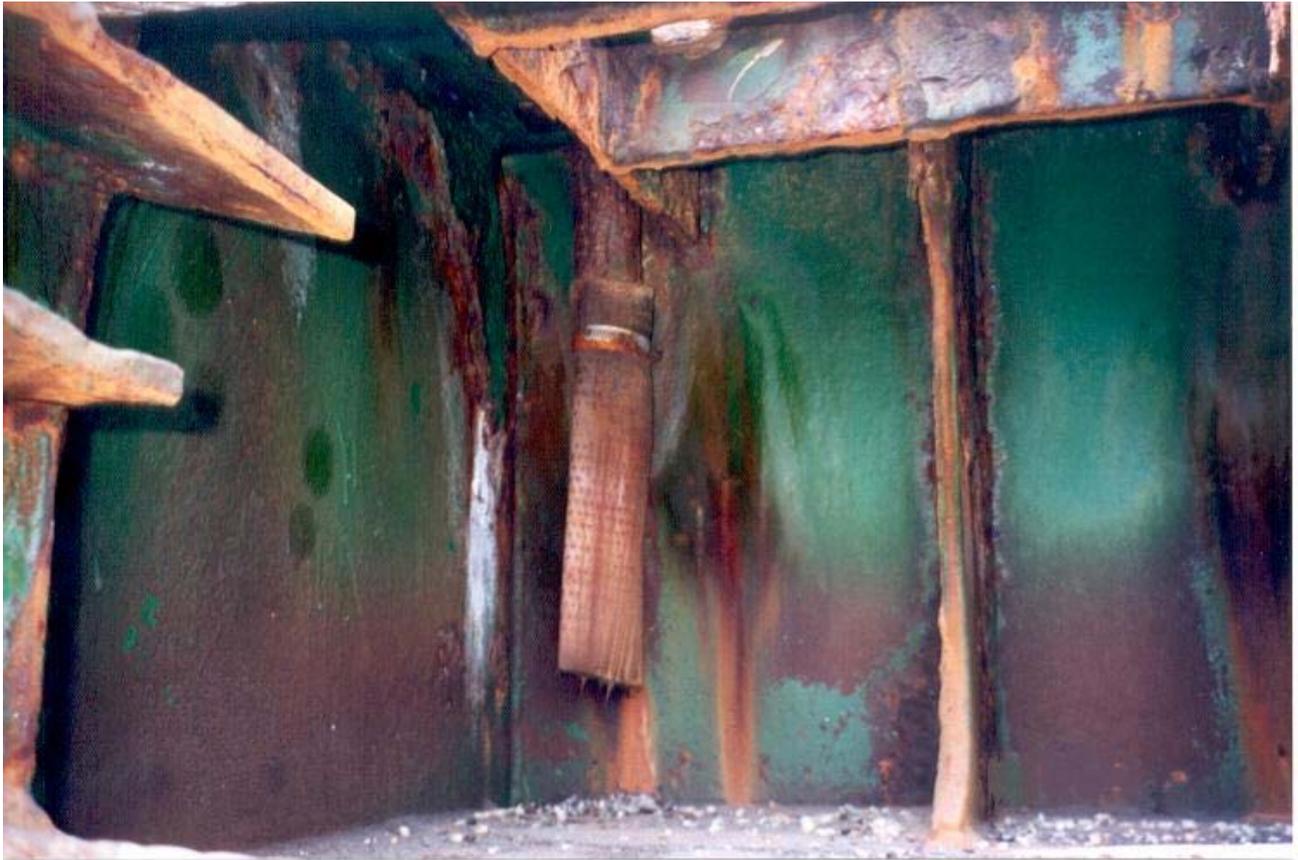
Whilst Classification Rules on the subject may be open to some interpretation, as can be seen from the extracts provided as an example above, short lengths of canvas hose attached to the drains are not usually accepted as being either "**non-return valves or equivalent**", or as being an "**approved automatic means**". Whilst it remains a mute point as to whether a length of canvas hose in good condition provides either an "**efficient**" or "**effective**" means of preventing water ingress, in the case of the Lloyds requirement, such hoses cannot be closed by a screw cap and therefore do not meet the requirements in any case.

It is essential therefore, that whatever approved device is fitted at the drains, it is in position and fully operational at the commencement of the voyage. Water ingress arising from wasted or missing sections of non return ball valve arrangements, open pipes, or even hardened lengths of canvas hose, cannot usually be defended as damages arising from heavy weather.
