Bulletin 367 - 06/04 - Further Information on Stowaways - Brazil

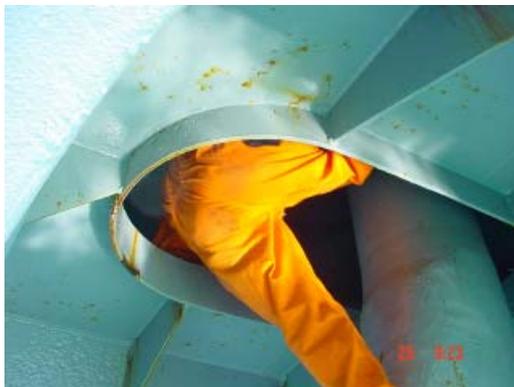
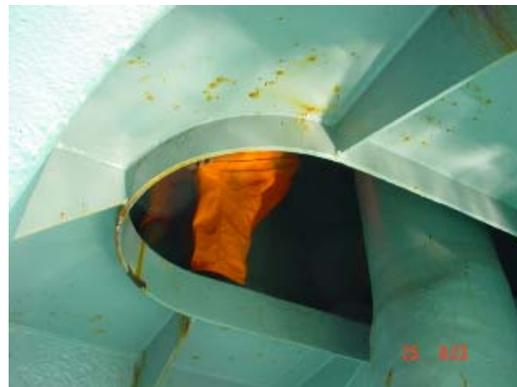
Stowaways have apparently discovered that the void space around the rudder stock is the best place to hide from the local stowaway search, since this place is not easily accessible from inside the ship. Crews should be instructed on this new stowaway strategy, intensifying the stowaway search to include the rudder housing. Crew may have access to the rudder housing by opening any of the available accesses in the steering gear room.

One case involved one of our Members ships, which was on a regular run between Djibouti and Yanbu al Bahr, Saudi Arabia. The ship was of conventional construction, but with a peculiarity in the rudder area which the stowaways could make good use of. On arrival at Jeddah anchorage where the ship called for bunkers, a stowaway was found sitting on top of the rudder assembly. This stowaway was a Kenyan national, who had entered the rudder cavity in Djibouti and had travelled for two days in the cavity, less than two metres above the water line with the noise of the propeller and steering gear constantly in his ears. When discovered, the stowaway was barely conscious.

We advise all Members of this situation and recommend that crews intensify stowaway searches and ensure that hard to reach positions on the ship, like the rudder housing, are thoroughly searched.
