Ship Type: All Trade Area: Worldwide

Bulletin 463 - 04/06 - Local use of Watertight Doors - Worldwide

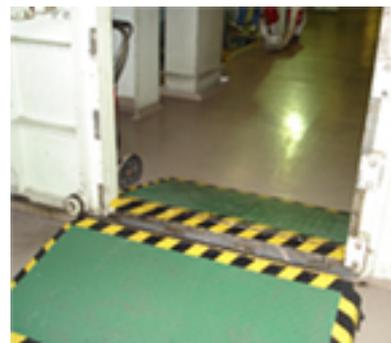
Some of the ship's senior officers stated during the investigation of this incident that crewmembers may think that by only partially opening the door they are committing less of a violation of the instructions given to them not to traverse closed doors. In fact this would make getting through the door in time more difficult and potentially more dangerous. Similarly, the officers explained that some crewmembers may attempt to quickly get through a closing door already opened by another crewmember. The dangers of these actions are real and need to be appreciated by all crewmembers.

Watertight doors can be dangerous and all members of the crew should be instructed in their safe operation. The UK Code of Safe Working Practices for Merchant Seamen advises that particular care should be taken when using power operated watertight doors which have been closed from the bridge. If opened locally, under these circumstances the door will re-close automatically with a force sufficient to crush anyone in its path as soon as the local control has been released. The local controls are positioned on each side of the door so that a person passing through may open the door and then reach to the other control to keep the door in the open position until transit is complete. As both hands are required to operate the controls, no person should attempt to carry any load through the door unassisted.
