Securing weather-deck hatch covers

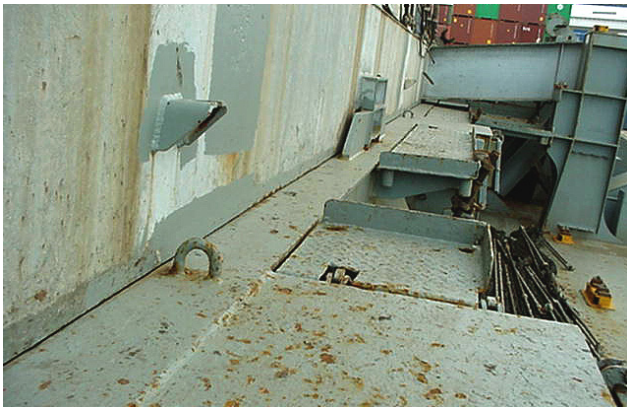
The Club's ship inspectors have recently visited vessels where it has been found that the load line regulations are regularly being contravened

It is a requirement of the load line rules that hatch covers, cleats and coamings be surveyed annually by the vessels flag state. This is a statutory requirement which applies to all ships.

During the building of a vessel, the weather-deck hatch covers and associated equipment which includes the securing arrangements are fitted in accordance with Classification Society rules. No changes to the hatch covers or to the associated equipment can be made without prior class approval.

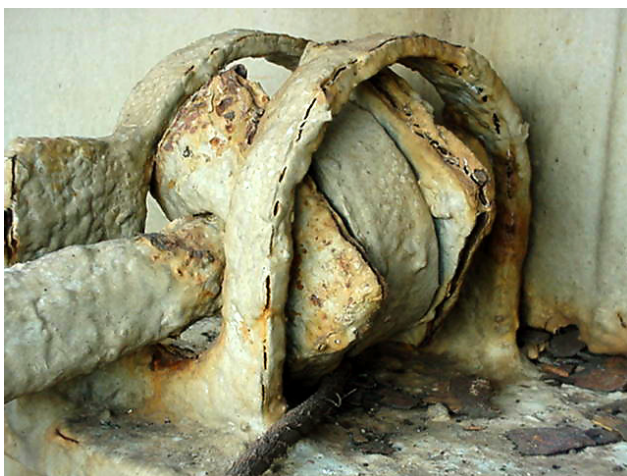
It has been noted that in order to expedite the securing of hatch covers when containers are loaded on to hatch tops manual securing cleats are frequently removed.

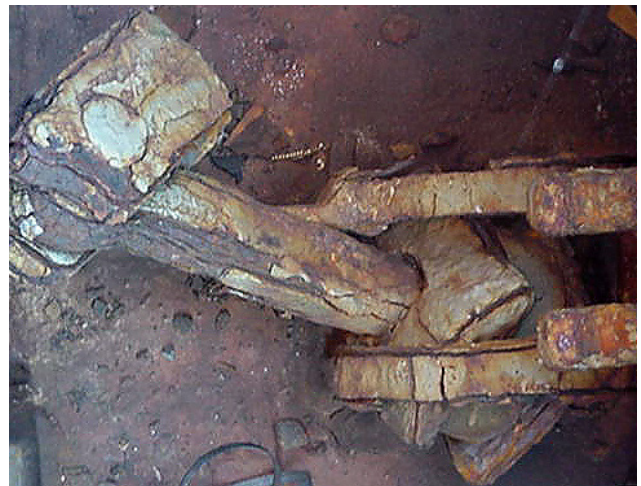
In other cases, the maintenance of the securing cleats has been neglected to such an extent that they have seized solid to the hatch coaming, ending up totally inoperative and painted over.
