Loss Prevention Bulletin

Ship Type: Container Trade Area: Worldwide

Bulletin 139 - 05/00 - Container Securing Equipment Problems

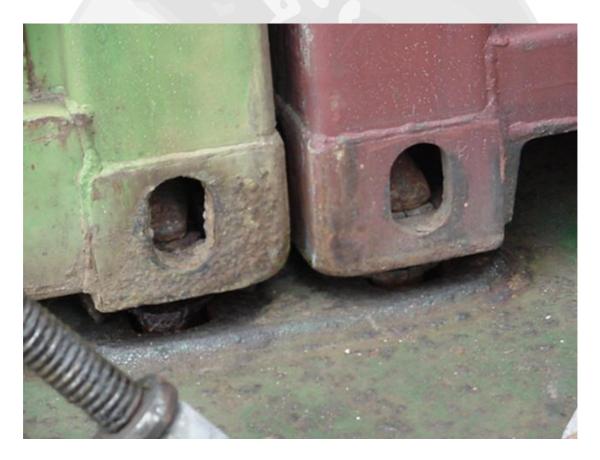
WRONG TYPE OF LOCKING DEVICE

On this particular ship the locking device at the base of the stow on deck is supposed to be a fixed cone with a large right angled pin which goes through the corner casting. The cone and pin are then is rotated 90 degrees effecting the locking mechanism. Instead of this the stevedores have used two broken twistlocks that have had their levers sheared off. The photograph shows clearly that the twistlocks are unlocked. As a result the containers are not locked to the deck. The only positive securing of the container stow is the lashing rods and turnbuckles that are secured to the second tier.

Two lessons here: remove broken or damaged twistlocks from the cargo area immediately they are noticed. Secondly, ensure that the stevedores are instructed on

the type of securing device to be used. The duty Mate should be checking that they follow the correct securing methods as required by the ship's Cargo Securing Manual.

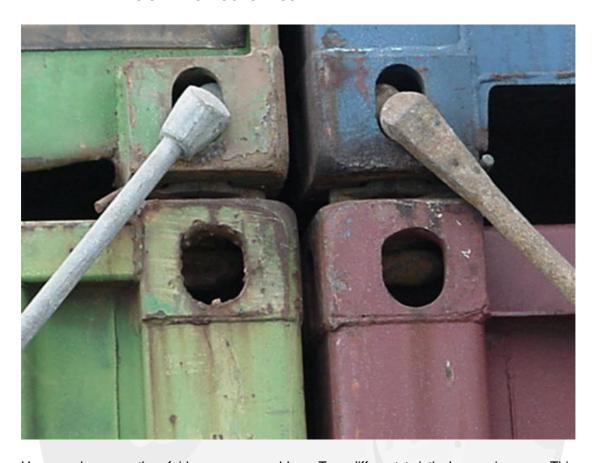
DIFFERENT TYPES OF TWISTLOCKS IN USE

Here we have another fairly common problem. Two different twistlocks are in use. This vessel should only use RH (right hand) locking twistlocks. Instead there are both RH and a LH locking twistlocks in the same stow. This can cause all sorts of problems. In a recent case a ship was discharging in Rotterdam and the stevedores had prepared the stow for discharge, removing the lashings and unlocking - as they thought - all the twistlocks. When discharge started one of the containers still had one corner locked on and as the port container crane lifted the loaded container it was momentarily held fast and then released suddenly. The container swung heavily and knocked into the mixed outboard stow of 40 foot and 20 foot containers with sufficient force to cause eight (8) containers to topple into the dock like dominoes. Fortunately most of the containers were empty but a loaded twenty footer narrowly missed the bunker barge that was on the starboard side at the time.

This problem of having mixed twistlocks should be checked for on a regular basis If any are sighted they should be marked and highlighted for removal from the ship.
