Bulletin 149 - 07/00 - Store Cranes - Testing, Inspection & Maintenance

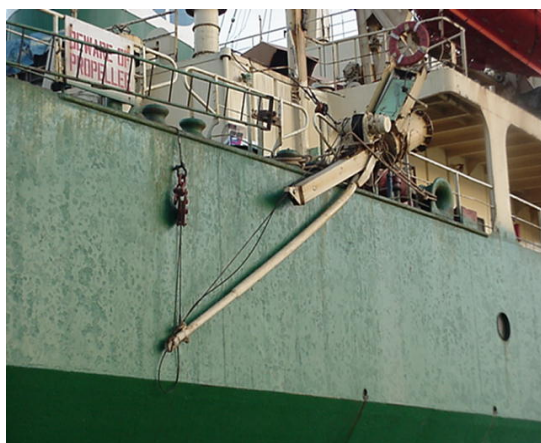
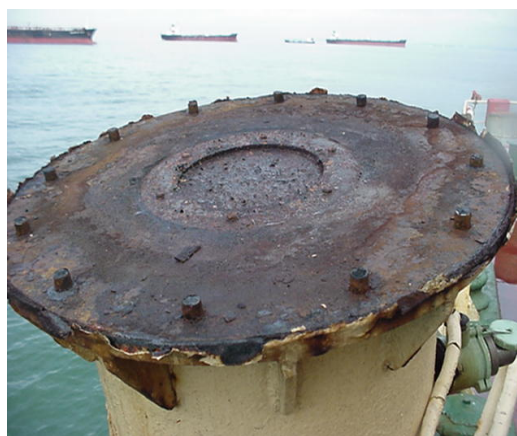
While lifting a cargo net load of ship's spares, estimated at under 300 kg, the 1 ton SWL stores crane was ripped from its base plate. The crane fell from boat deck level to the aft quarterdeck and became jammed in the debris of the ship's crushed side rails. The crane was left precariously positioned over the ship's side with the jib pointing down but with the cargo net still attached and submerged into the sea. Fortunately, no personnel were injured during the incident. The cargo net was eventually recovered but with the loss of some very valuable generator spares and other items.

The main cause of the crane failure is still unclear. However, it was established that considerable time had elapsed since the stores crane was last tested / inspected. The ship had left drydock two weeks previously where the ship's main derricks had been tested and the Cargo Gear Book revalidated but no testing / inspection of the stores crane had taken place.

Members' attention is drawn to the desirability of scheduled testing, inspection and maintenance of **ALL** lifting appliances. It would be expected to find procedures to cover the safe operation and maintenance of all lifting appliances under the ISM Code and Safety Management Systems.
