Ship Type: All Trade Area: Worldwide

Bulletin 388 - 11/04 - Burn Incident - Hot Oil Cargo

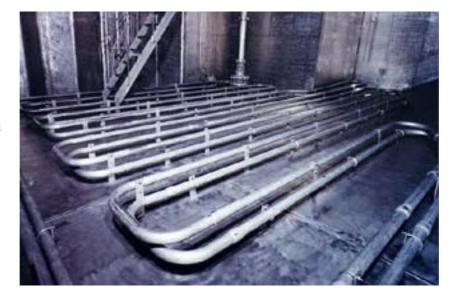
We have been made aware of a recent incident which resulted in two burn casualties onboard a ship discharging refined palm stearin. Palm stearin is an oil cargo carried in heated tanks to prevent it from solidifying. The image below demonstrates the layout of the steam heating coils on the tank top.
