Bulletin 494 - 11/06 - Asbestos in Dunnage - China

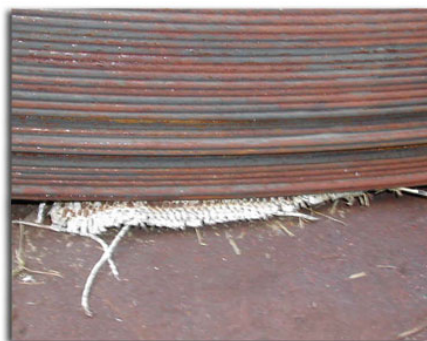
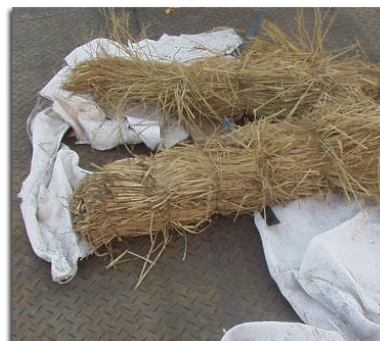
If crew see woven matting such as that pictured below, loading should cease and advice immediately sought on how to assess if the matting contains asbestos. If asbestos is found to be present, it should not be handled by the ship's crew, but arrangements should be made for the matting to be safely removed. The Club's correspondents should be involved to assist ship's crew.

The type of asbestos found on the entered ship is chrysotile, which can be woven into insulating mats but breaks into straw-like strings.
