Ship Type: All Trade Area: Worldwide

Bulletin 514 - 03/07 - Crew injured using gas cutting equipment - Worldwide

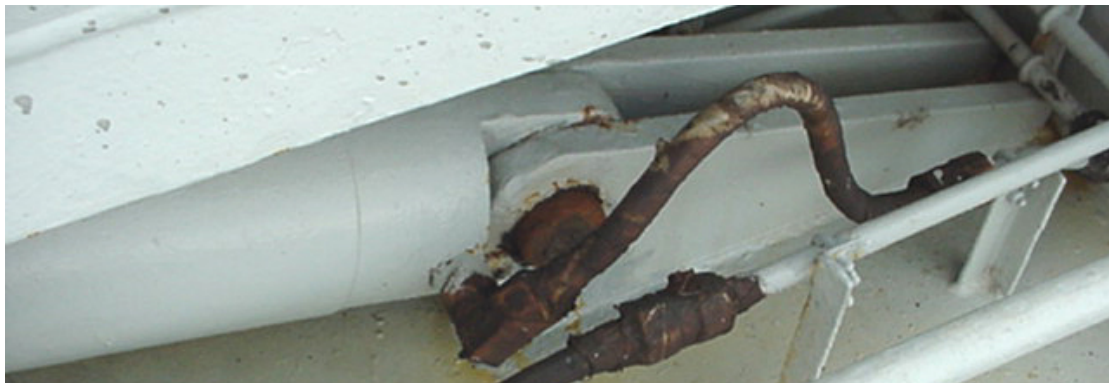
Hatch cover hydraulics (this image is not associated with any of the incidents described in this bulletin)

This is yet another incident that highlights the need for hot-work to be planned and supervised and crew should be briefed in this respect.
