# LP Bulletin

## Bulletin 845 - 09/12 - Increased Fishery Farm Claims - Korea

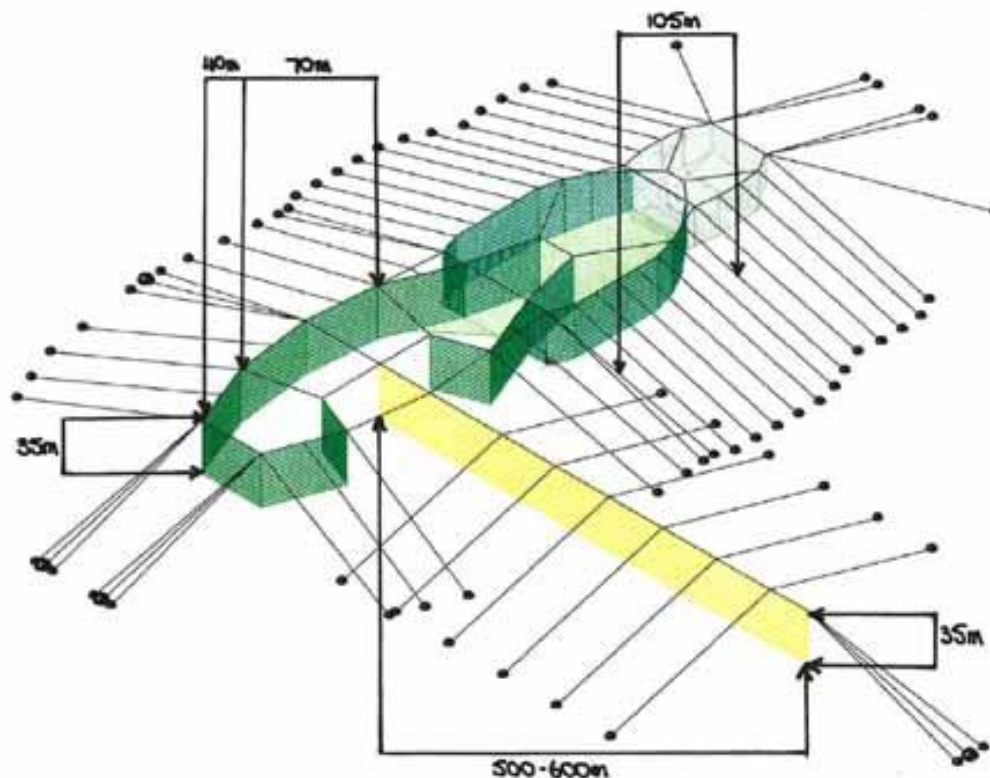
Earlier in the year the Club was exposed to a claim when an entered vessel ran through one of these fish farm installations. As can be seen from the diagram below the structure can stretch over half a kilometre wide and can reach up to 35m from the seabed.

The claim against the Club rose to in excess of \$350,000 due to damage to the structure itself and a loss of earnings while the structure was repaired.

These fish farm installations can be poorly marked often by buoys with no lights. They have no radar signature or AIS markers. More often than not they are not charted individually. Members are advised to pay particular attention to notices, especially local notices which will promulgate the position of future fishing grounds.
